NASA Technical Memorandum 83786

Fracture Surface Characteristics of Notched Angleplied Graphite/Epoxy Composites

Carol A. Ginty and Thomas B. Irvine
Lewis Research Center
Cleveland, Ohio

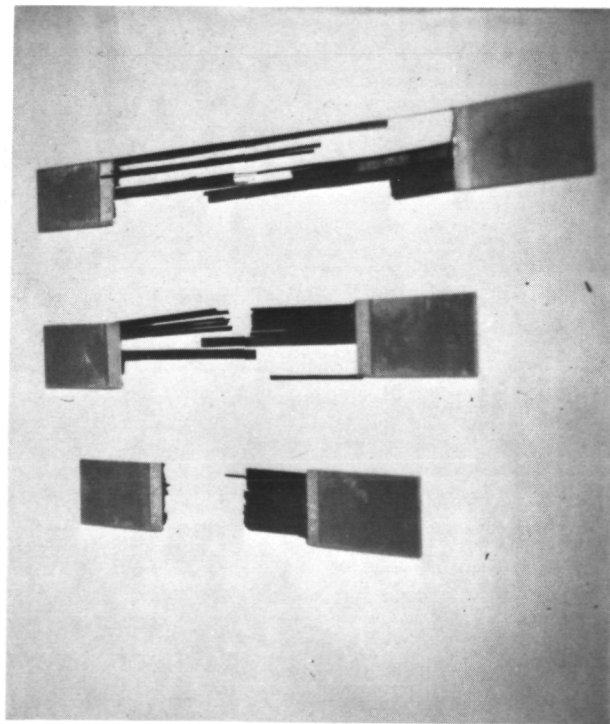
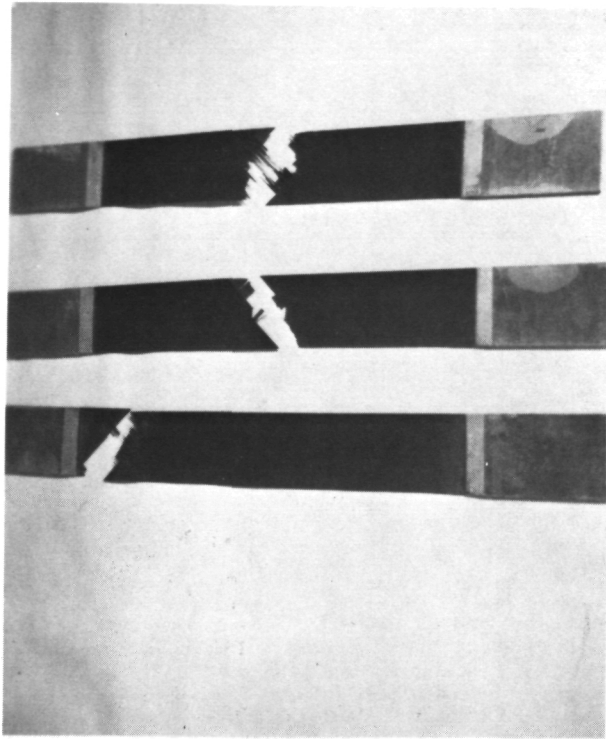
Uniaxial tension testing of the specimens was conducted in an incremental load-to-fracture manner using a 50 kip load frame with a prescribed load increment size. Fracture was catastrophic for the lower angle (0° to 15°) G/E specimens leaving very little of the composite intact (fig. 1(a)). The remaining angleplied specimens (30° to 90°) exhibited a brittle fracture process that produced puzzle-like pieces of the composite as the specimens broke apart (fig. 1(b)). Table I lists the fracture loads of the solid and notched specimens for each laminate configuration in the series.

Figure 1. - Fractured G/E specimens from left to right --- solid, notch/slit and notch/hole.

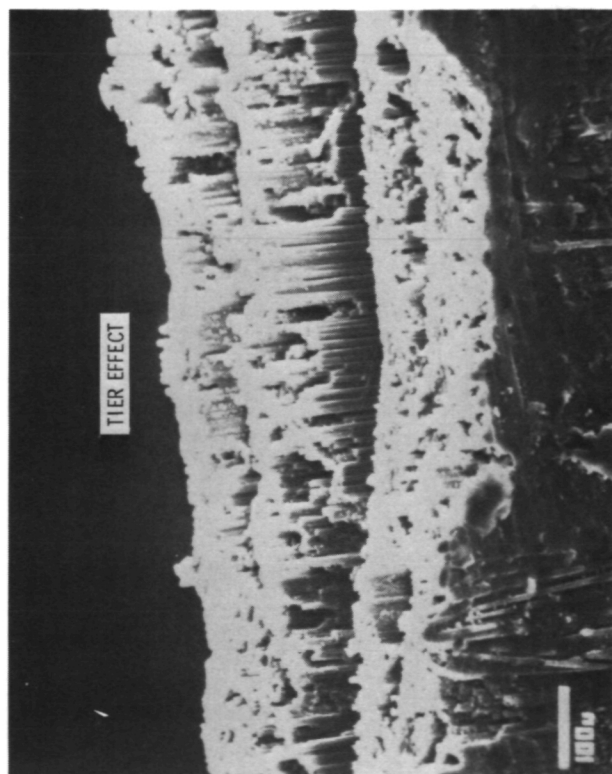
(a) 120X.

The fracture surface characteristics of the notched G/E unidirectional laminate are presented in figure 2. The distinguishing feature of the fracture surface is the tiered fibers (ref. 2) as seen in figure 2(a). This tiered effect is the result of fiber pull-out caused by fibers breaking at various locations along the length of the fiber. Note that the fiber surfaces in figure 2(c) are relatively clean and free of matrix residue. This unidirectional laminate being tested in longitudinal tension will fracture due to a longitudinal tensile mode. Therefore, the microstructural characteristics just described are indicative of a longitudinal tensile fracture mode with the tiered surface being the primary microscopic feature.

Figure 2. - Microstructural fracture surface characteristics of a notch/slit unidirectional G/E laminate. The dominant characteristics are the tiered and pulled-out fibers.

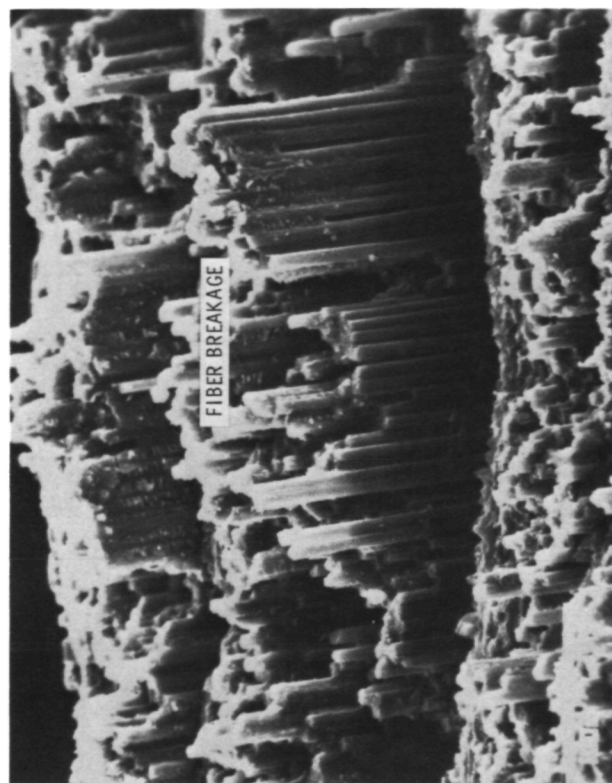
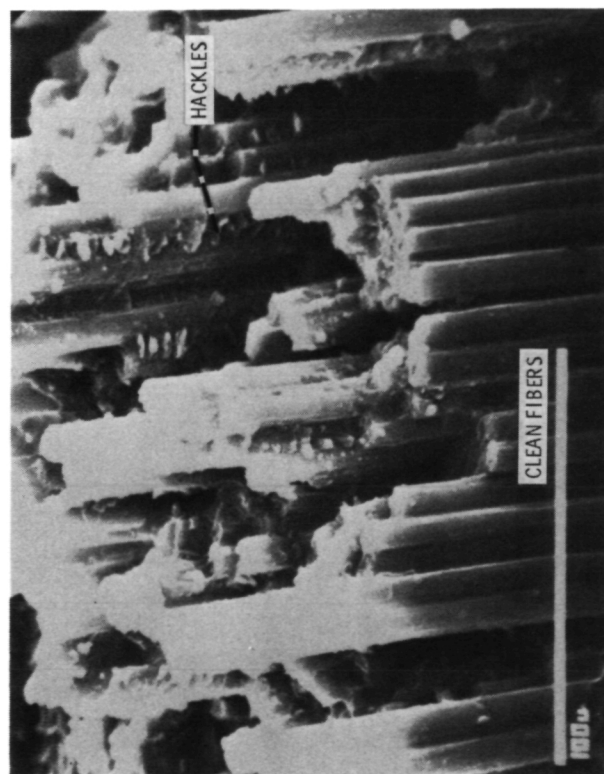
At greater magnifications (figs. 2(b) and (c)) a characteristic associated with an intraply shear mode is observed. This characteristic is represented by the presence of matrix debris being squeezed out between the fibers. This characteristic is referred to here as matrix hackles. The amount of matrix hackles present is minimal indicating that even though a shearing mode did exist, its contribution to final fracture was minimal and that the primary mode of fracture for this unidirectional laminate was a longitudinal tensile mode.

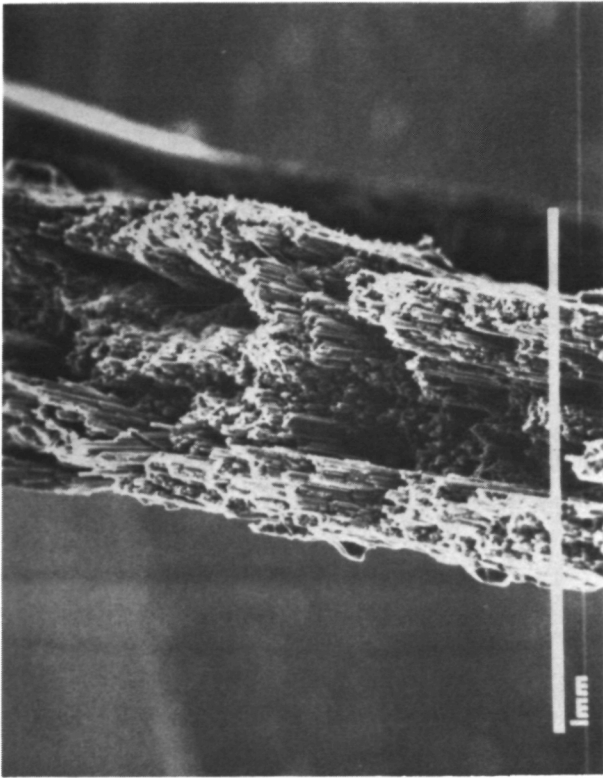
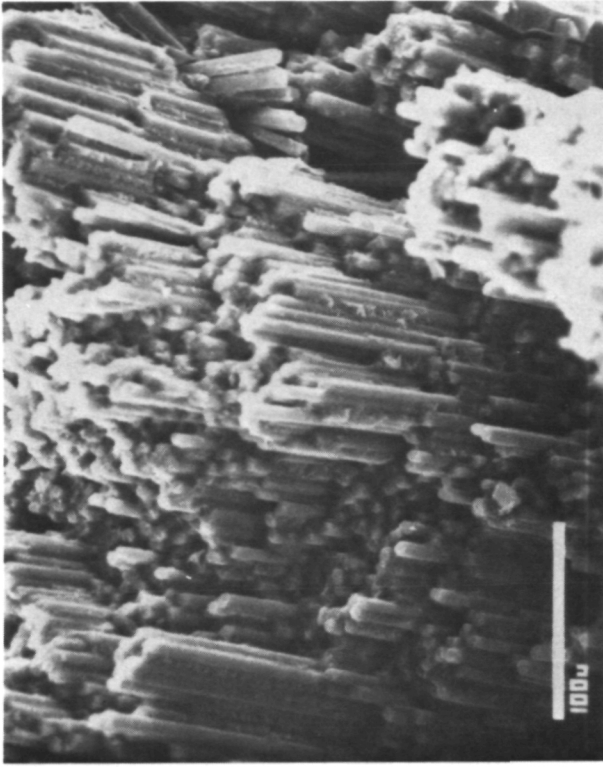
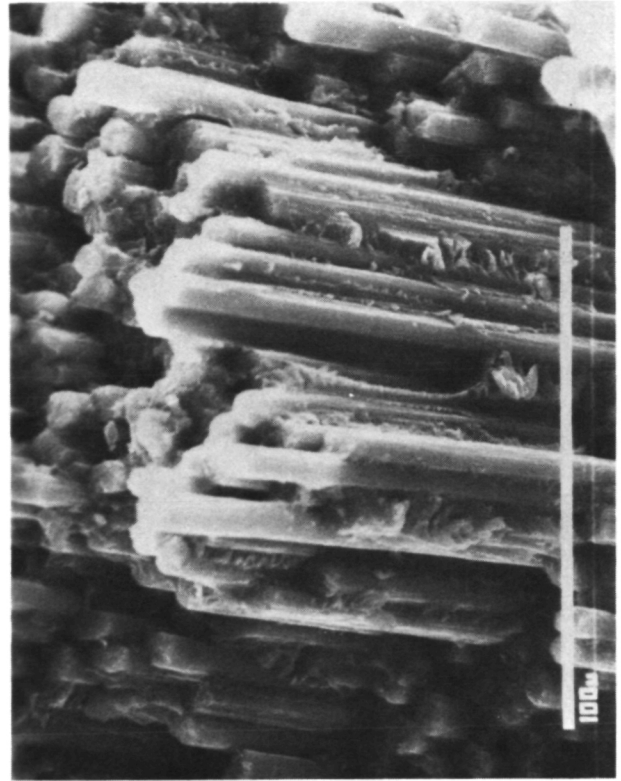
The same microstructural characteristics depicted for the unidirectional laminate are observed on the fracture surface of the $[\pm 3]_s$ laminate (fig. 3). Although the characteristics are similar, there is a distinct change in the tier formation. Figures 3(a) and (b) show fiber pull-out and breakage occurring more randomly. This action still produces an irregular fracture surface but without the wall-like formation of each ply that existed for the unidirectional laminate. In figure 3(c), matrix hackles are apparent indicating an intraply shearing action. Nevertheless, final fracture was the result primarily of a longitudinal tensile fracture mode.

Figure 3. - Photomicrographs of the $[\pm 3]_s$ G/E laminate fracture surface. The predominant characteristic is the fiber breakage.

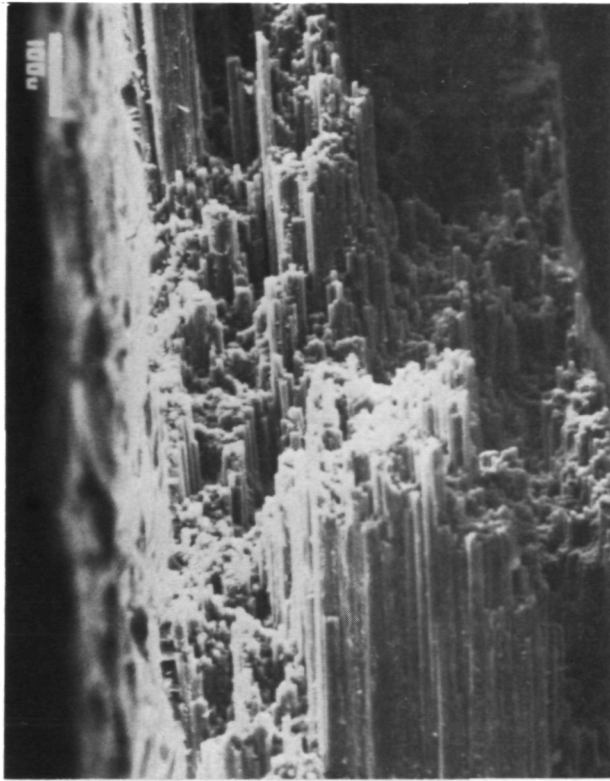
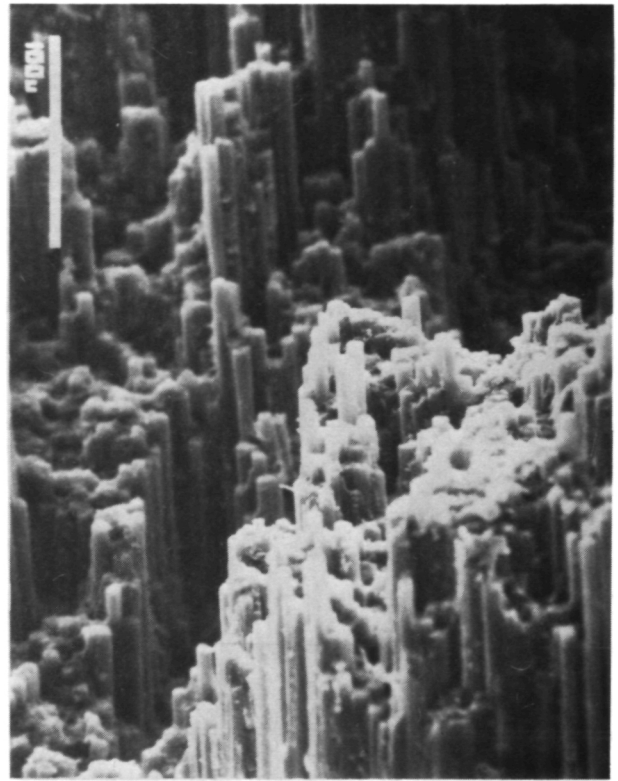
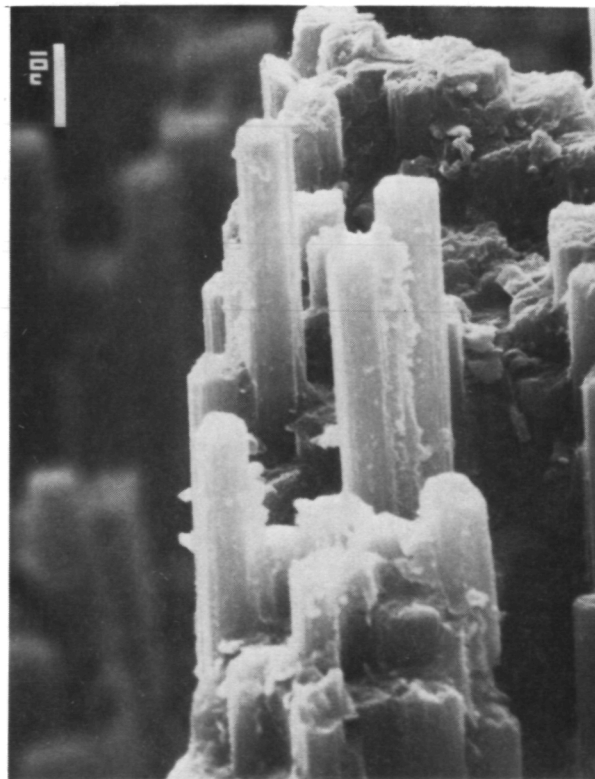
Fiber pull-out and breakage is the dominant trait of the $[\pm 5]_s$ fracture surface displayed in figure 4. Although the surface is still irregular, individual fibers appear to be breaking at the same locations along the fiber resulting in a leveling-off effect. Matrix hackles are more evident suggesting that even though longitudinal tension is still the primary mode of fracture, intralaminar shear is becoming a larger contributor to final fracture.

Figure 4. - Microstructure of the fracture surface of the $[\pm 5]_s$ G/E laminate revealing fiber breakage accompanied by matrix hackles.

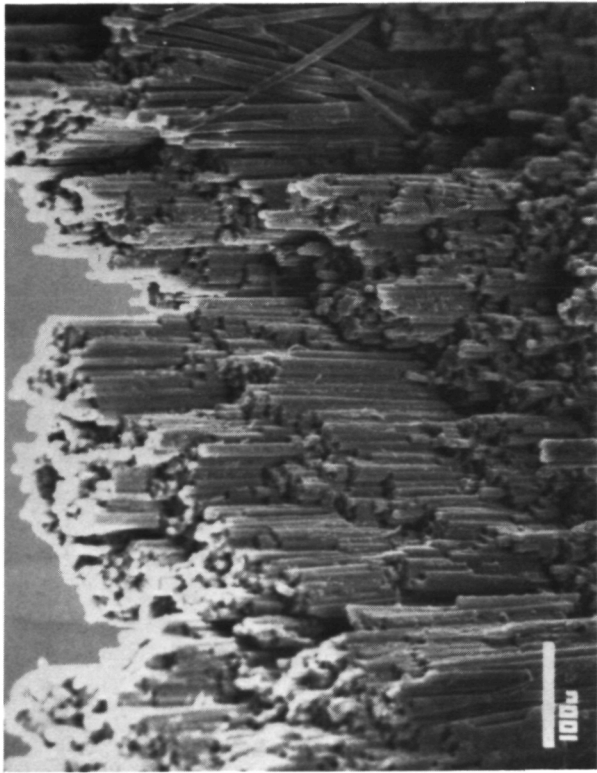
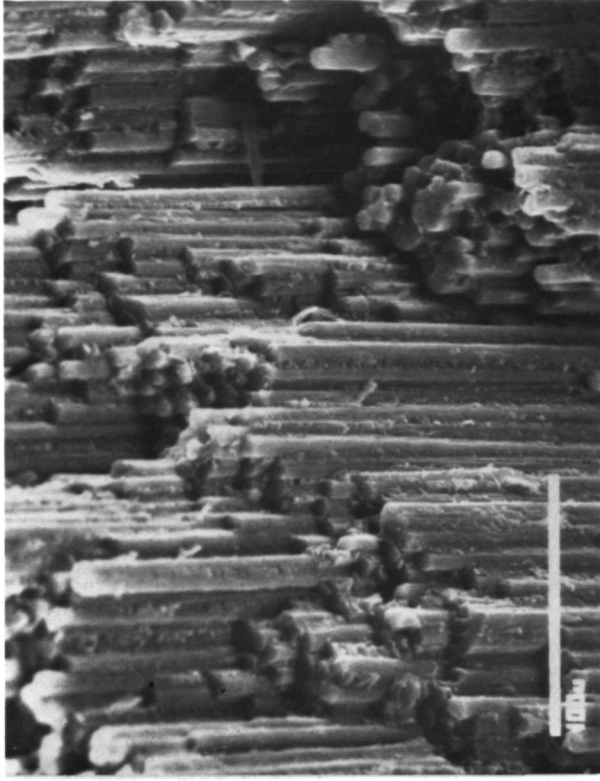
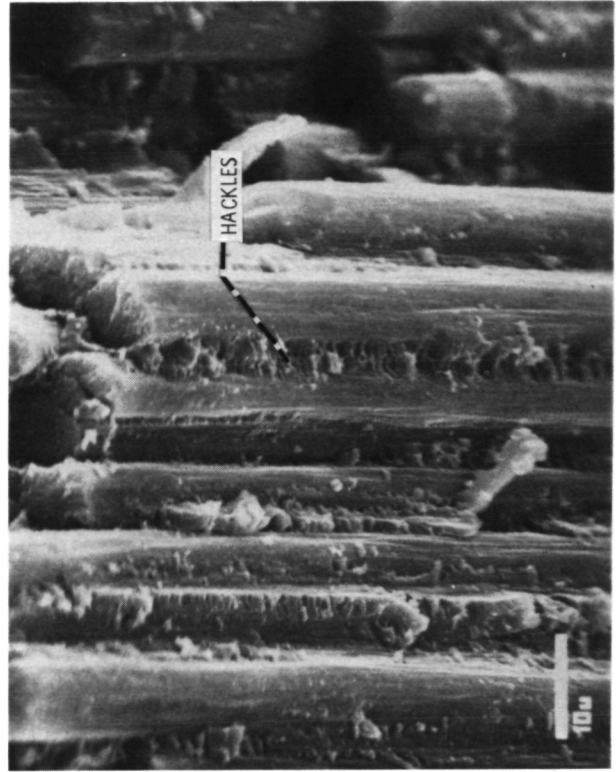
Irregular fracture surface and fiber pull-out are still the outstanding microstructural characteristics for the $[\pm 10]_s$ laminate exhibited in figure 5(a). The photomicrograph in figure 5(b), however, reveals a cluster of fibers with relatively clean surfaces breaking at approximately the same place indicating a combination of longitudinal tensile and intraply shear modes respectively. Figures 5(b) and (c) show matrix hackles appearing in an established pattern between the fibers instead of the random occurrence which was previously observed.

Figure 5. - The fracture surface of the notch/slit [$\pm 10^\circ$]s G/E laminate revealing matrix hackles between the fibers.

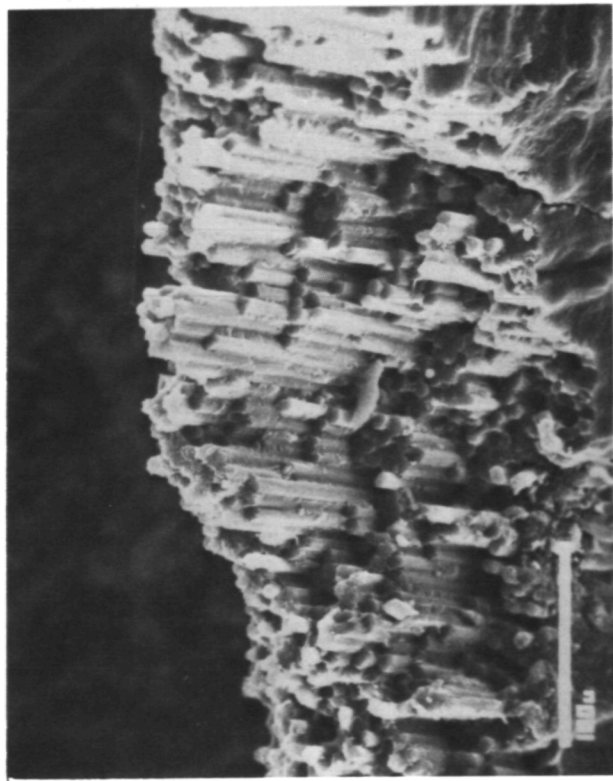
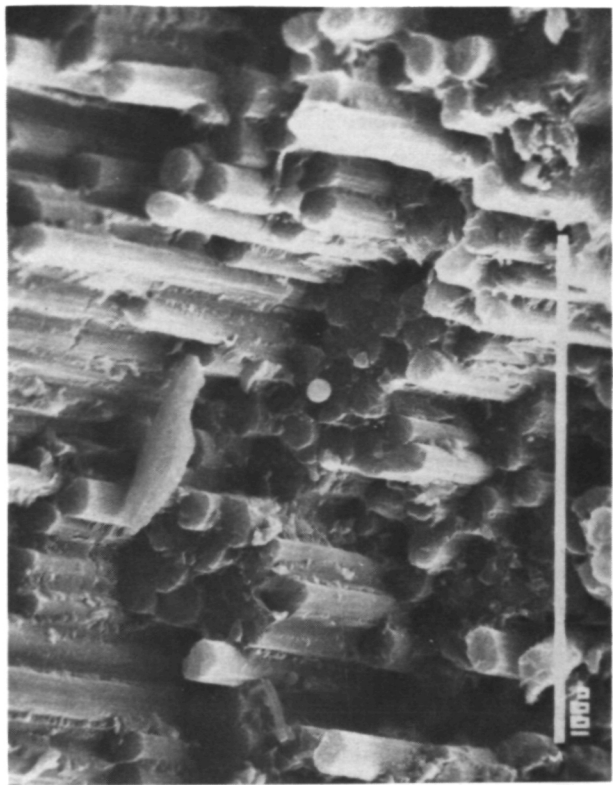
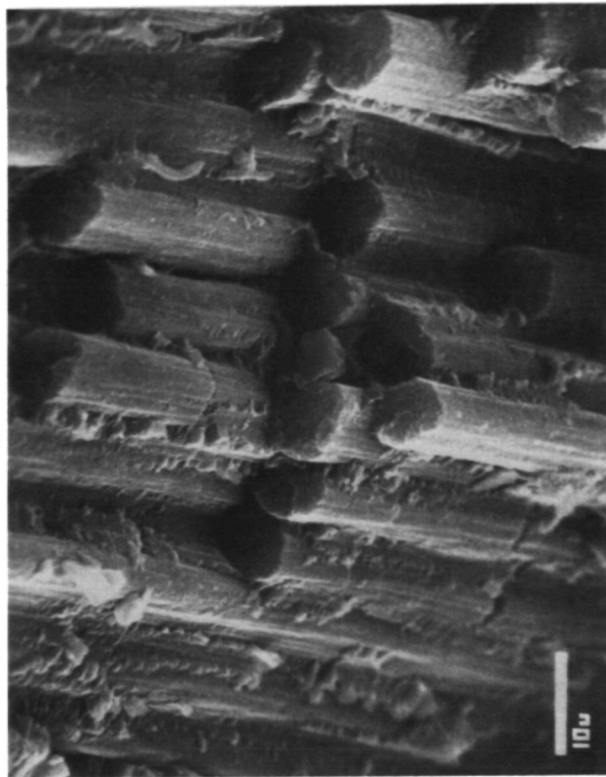
Photomicrographs of the $[\pm 15]_s$ laminate fracture surface are presented in figure 6. The irregular surface (fig. 6(a)) and the clean fibers along with the fiber pull-out (fig. 6(b)) indicate a longitudinal tensile fracture mode. Figure 6(c) reveals not only an abundance of matrix hackles but also matrix debris on the surfaces of the fibers which are now forming a level surface, indicative of an intraply shear fracture mode.

Figure 6. - Photomicrographs revealing the microstructure of the $[\pm 15]_s$ G/E fracture surface. Longitudinal tensile and intraply shear fracture modes are characterized by the fiber fracture and matrix hackles respectively.

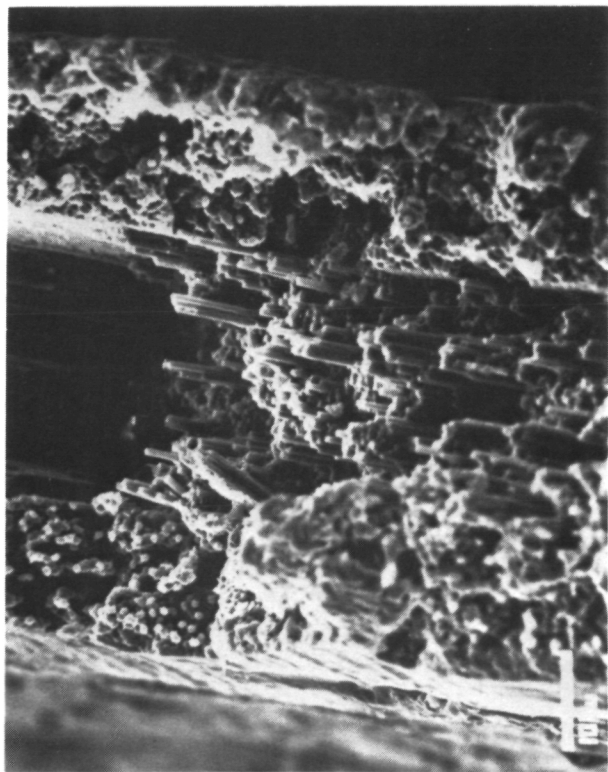
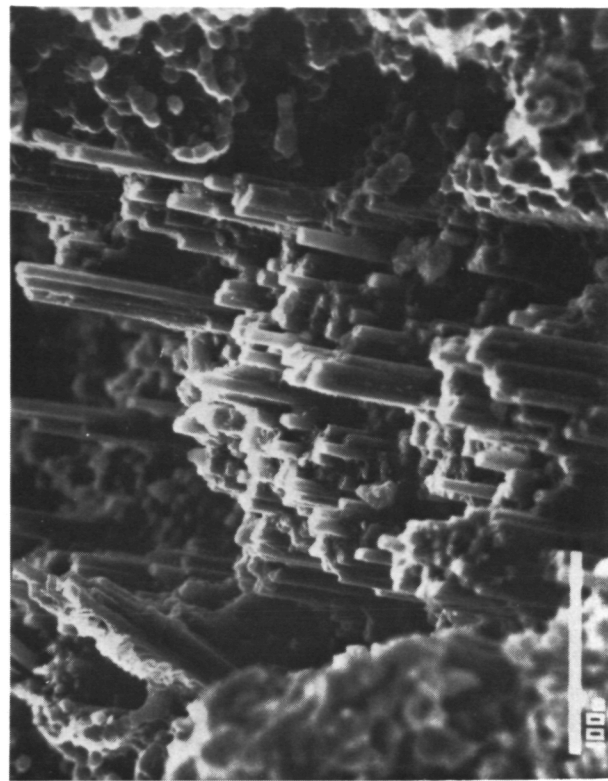
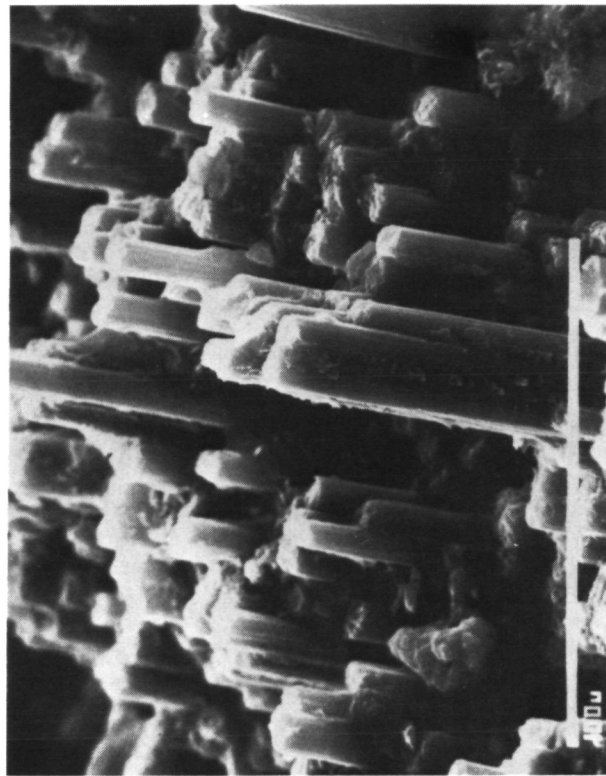
A significant change in the microstructure of the fracture surface is observed in the photomicrographs of the $[\pm 30]_5$ laminate in figure 7. Fibers in the outer plies (+30) are breaking at approximately the same place producing a level surface while the inner plies (-30) are still experiencing fiber pull-out and breakage in different locations. The number of fibers affected by this longitudinal tensile fracture mode is decreasing (fig. 7(b)). At the same time, with the presence of matrix hackles and debris increasing (fig. 7(c)), it appears as though intraply shear is becoming the dominant mode of fracture as the ply angle orientation increases.

Figure 7. - Fracture surface characteristics of the $[\pm 30]_s$ notch/slit G/E specimen. The fibers broke at or near the same place producing a more level surface.

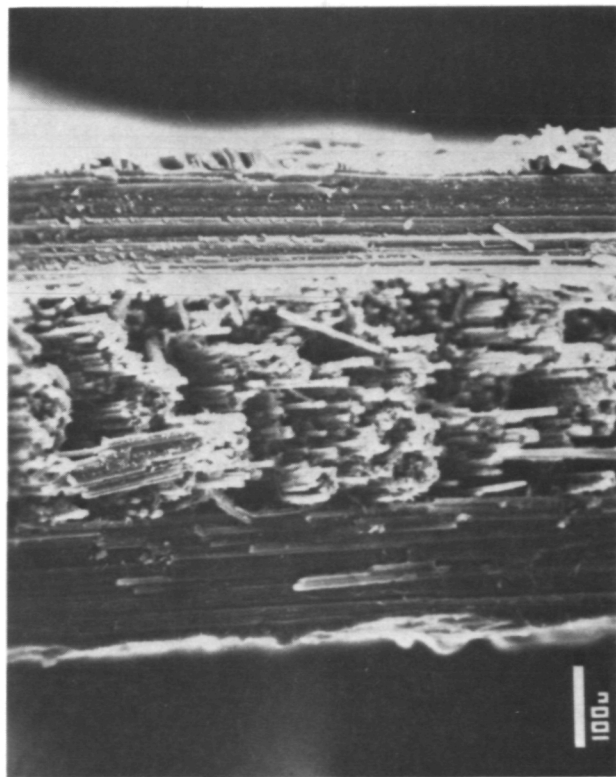
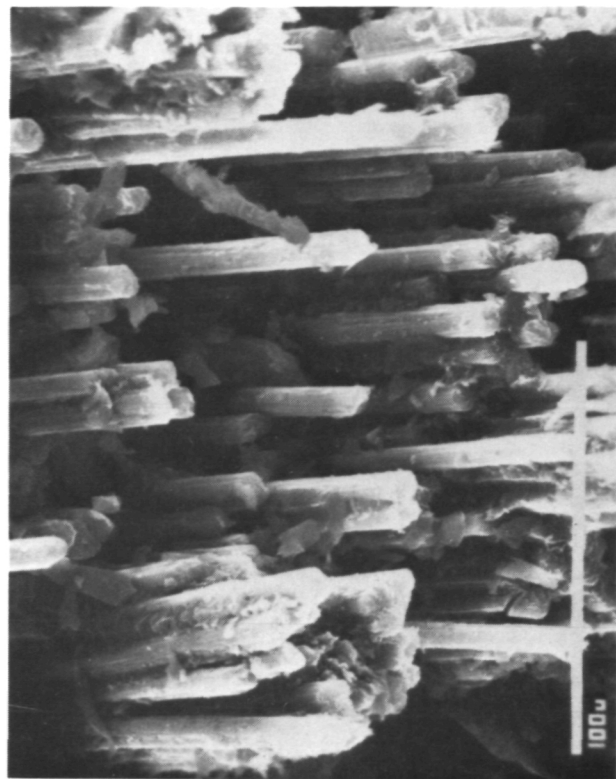
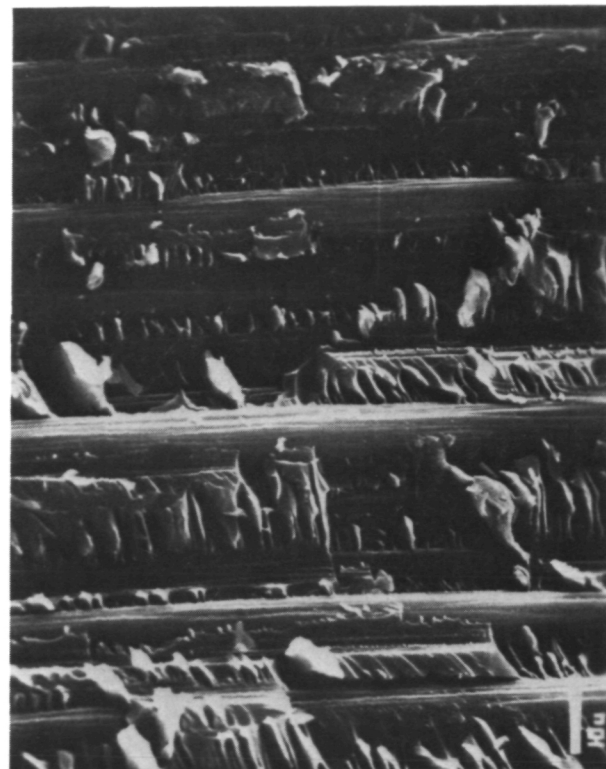
The prominence of intraply shear controlling the fracture process is illustrated in figure 8 which displays the fracture surface of the $[\pm 45]_5$ laminate. The outer plies now consist of an entirely level surface. The distinct characteristic of the intralaminar shear mode is clean fiber surfaces surrounded by matrix hackles which is clearly depicted in the magnification of the outer level plies (fig. 8(c)). Figure 8(b) characterizes the longitudinal tensile fracture mode; however, the pulled-out fibers contain much matrix debris indicating the presence of an intraply shear fracture mode which is the primary cause of fracture for this laminate.

For the angleply ($[\pm 45]_5$) laminate, final fracture for the notched specimen was attributed to a combination of both longitudinal tensile and intralaminar shear modes with the shearing mode being dominant. CODSTRAN predicted that the same laminate would fracture due to a combination of interply delamination and intraply shear modes.

Figure 8. - Photomicrographs depicting the fracture characteristics of the $[\pm 45]_s$ G/E laminate. Intralaminar shear fracture designated by matrix debris and hackles is the primary cause of final fracture.

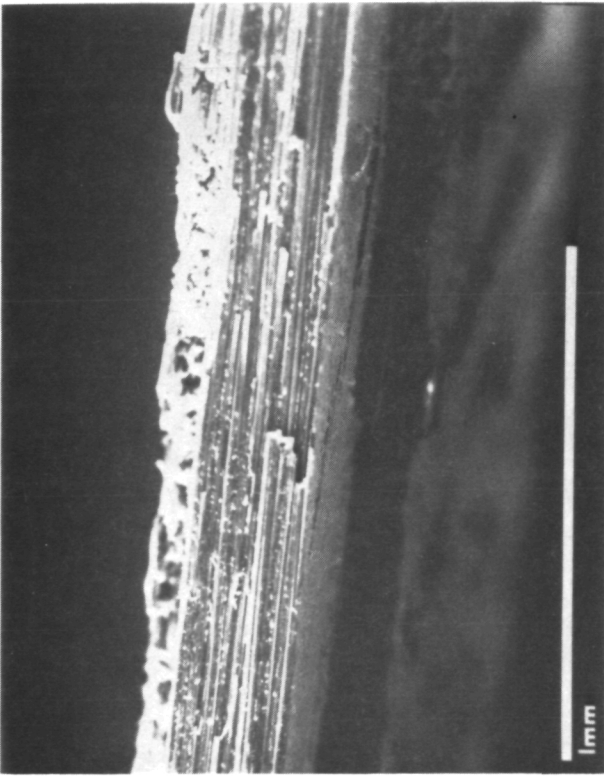
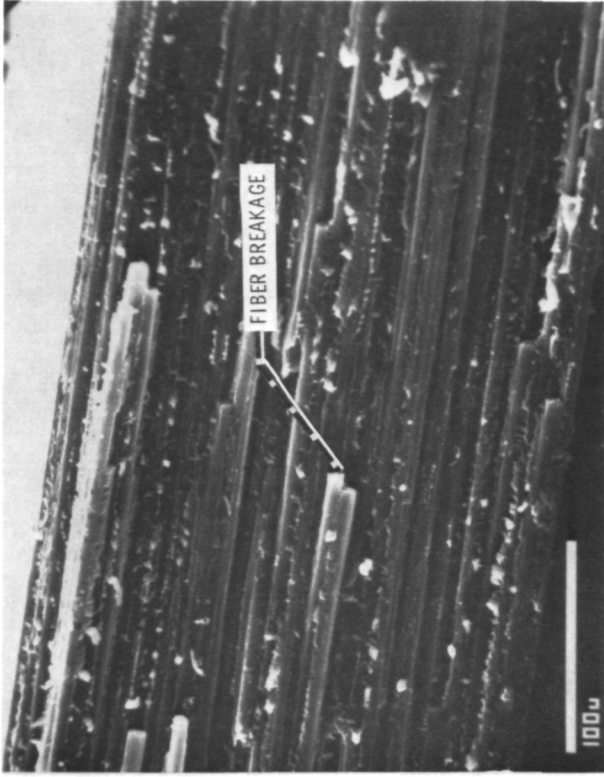
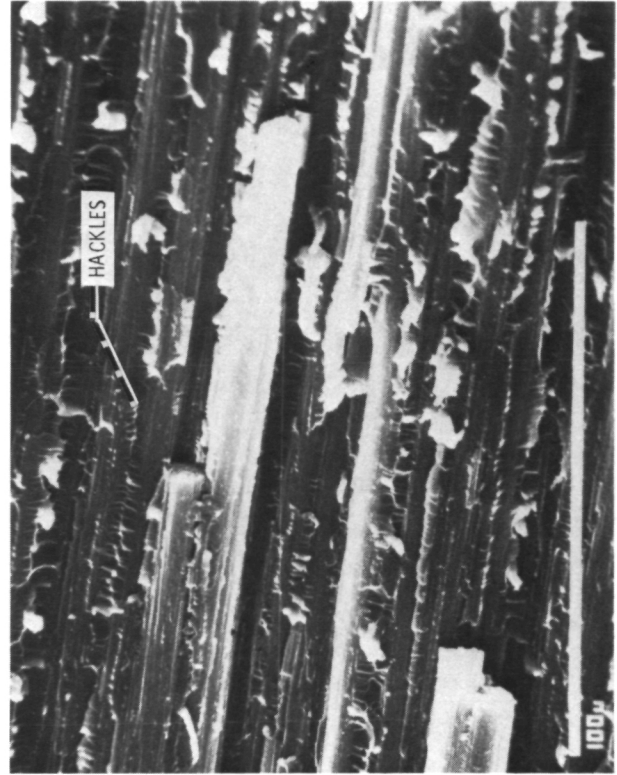
The fracture surface of the $[\pm 60]_5$ G/E laminate in figure 9(a) is entirely flat with no sign of fiber pull-out. Some fiber breakage (fig. 9(b)) did occur but in the transverse direction. These microstructural characteristics are indicative of a transverse tensile fracture mode. The extensive presence of matrix hackles exhibited in figure 9(c) represents the intraply shear fracture mode which also induces final fracture in this laminate.

Figure 9. - Fracture surface characteristics of the $[\pm 60]_s$ G/E laminate. The flat surface is indicative of a transverse tensile mode of fracture.

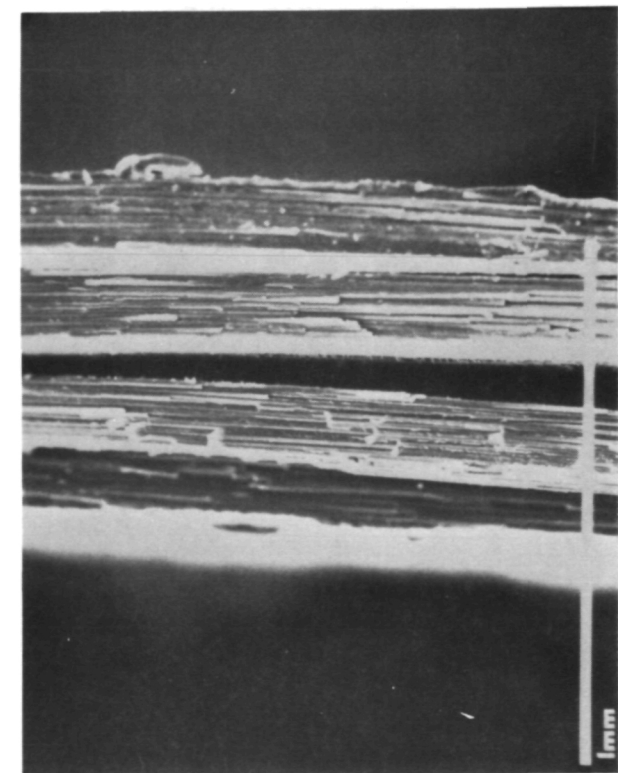
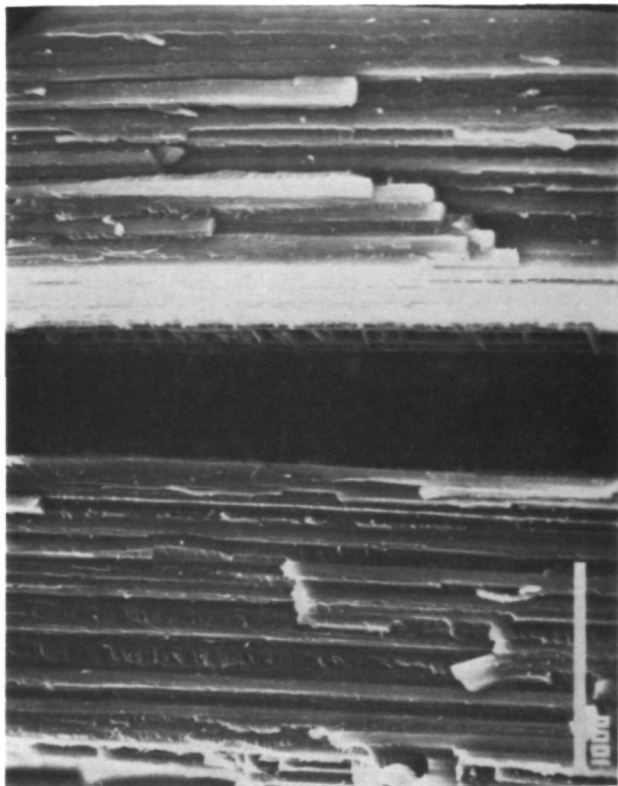
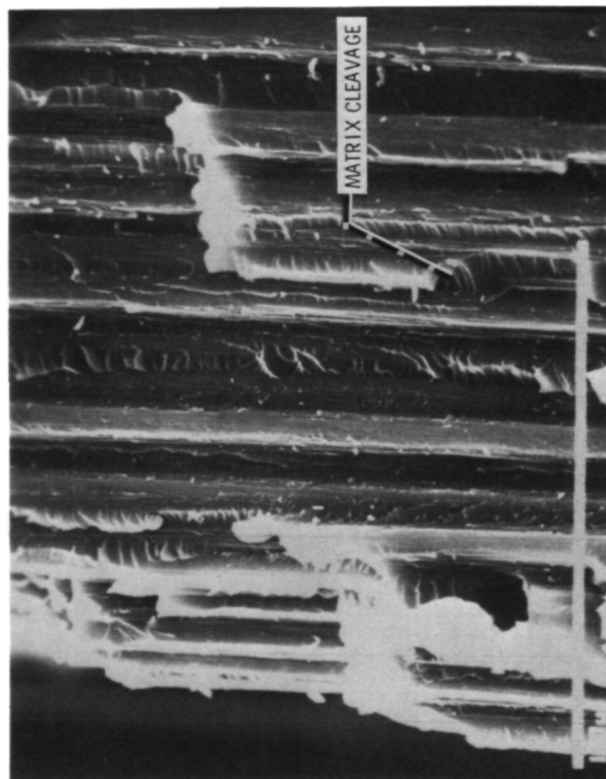
More fiber breakage occurring in the transverse direction on the flat fracture surface of the $[\pm 75]_5$ laminate is shown in figures 10(a) and (b). A new characteristic, matrix cleavage, was observed on this surface and is illustrated in figure 10(c). Matrix cleavage resembles a cutting or hollowing-out of the matrix between relatively clean fibers. The microstructural characteristics of this laminate are the result of a transverse tensile fracture mode.

Figure 10. - In addition to the flat features, the $[\pm 75]_s$ G/E fracture surface consists of fiber fracture and matrix cleavage.

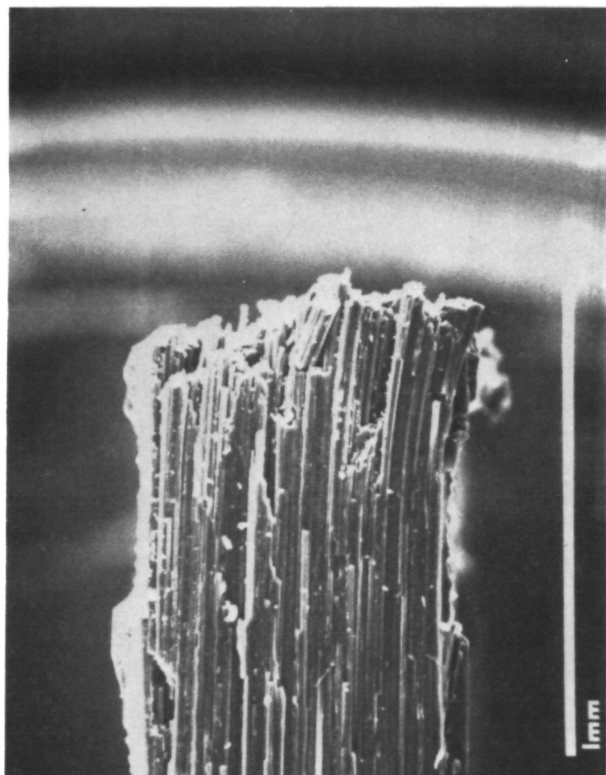
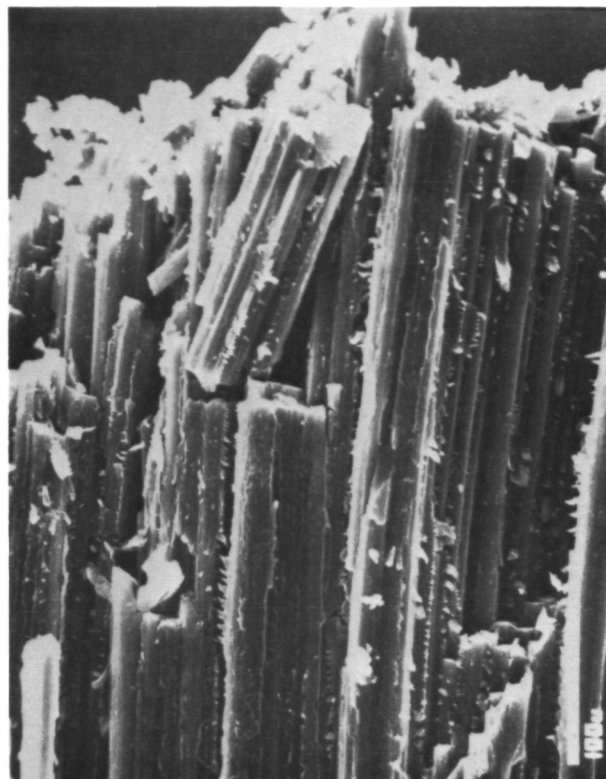
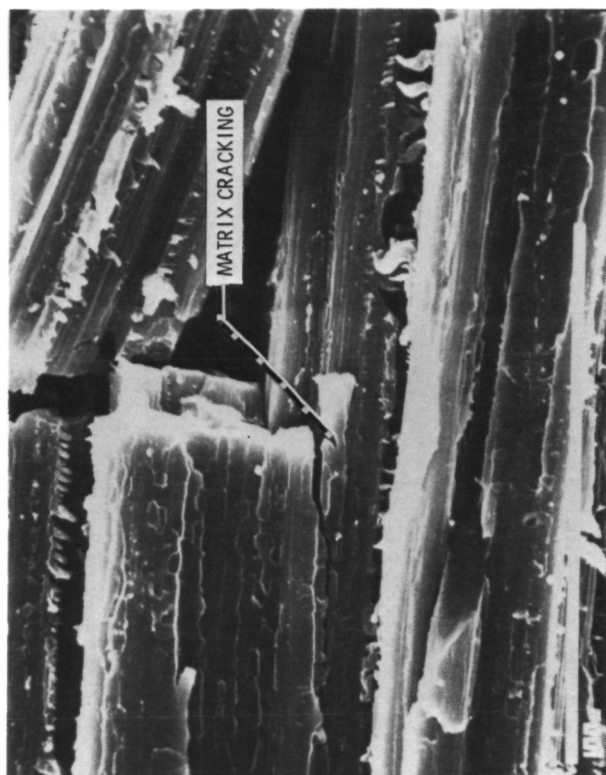
The final fracture surface to be examined is that of the $[90]_4$ G/E laminate presented in figure 11. The flat fracture surface reveals some fiber breakage in figure 11(a). With the occurrence of extensive matrix cracking, the specimen is beginning to fall apart (fig. 11(b)). Magnification of the specimen's edge exposes the matrix cracking and cleavage which causes the fracture due to a transverse tensile fracture mode.

Figure 11. - The fracture surface of the notch/slit $[90]_4$ G/E laminate consists of considerable matrix cleavage and cracking.

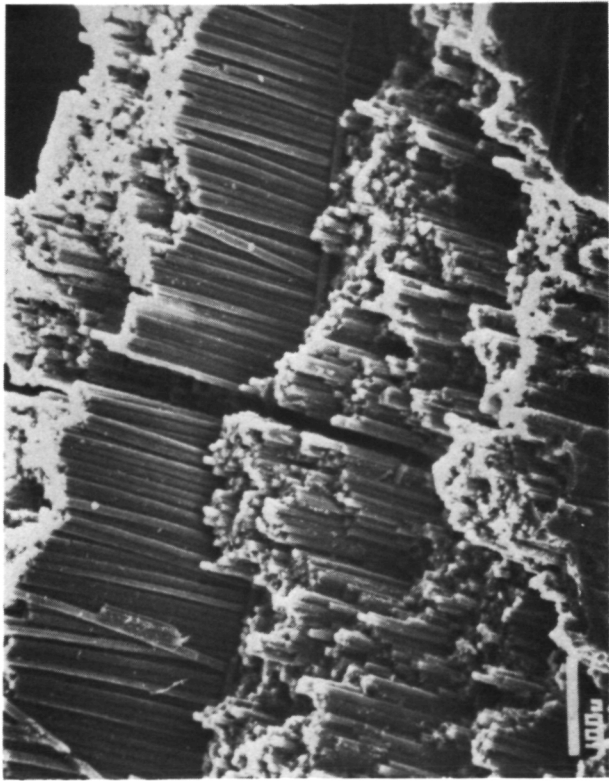
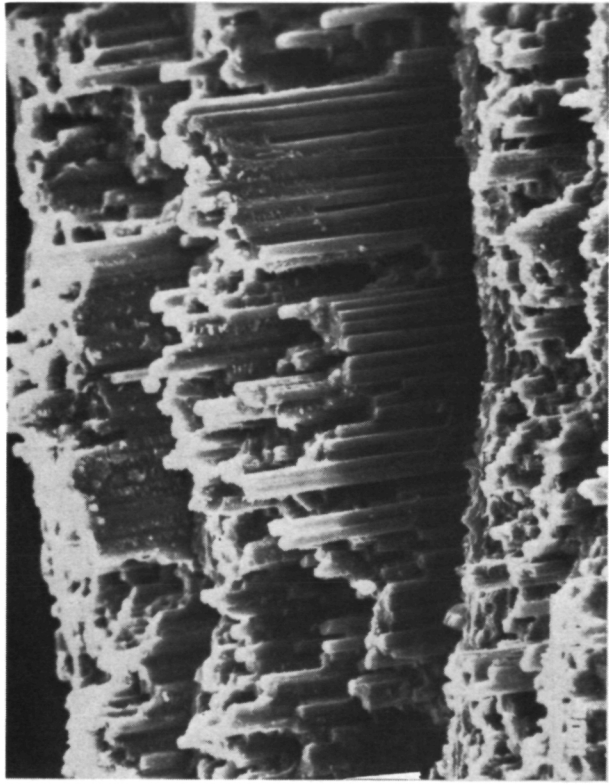
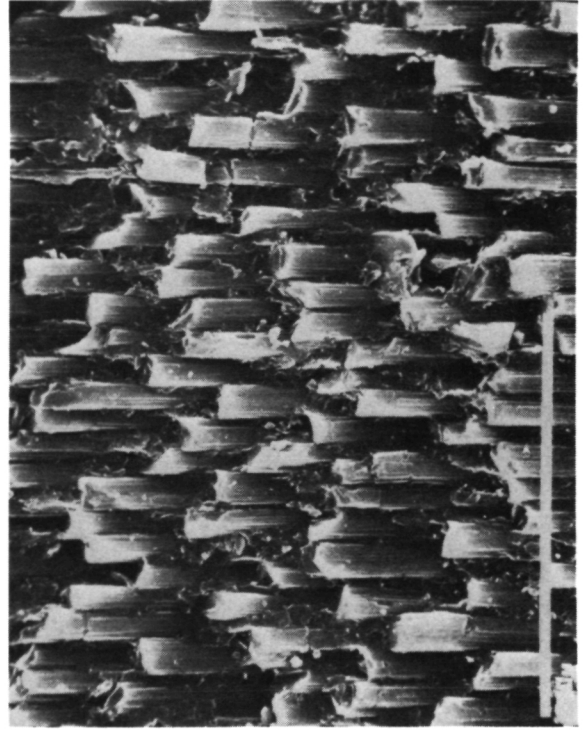
Through the microscopic analysis, it was revealed that neither the presence of a defect nor the type of defect had any affect on the fracture surface microstructural characteristics and thereby the fracture modes. This is illustrated in figure 13 for the unidirectional laminate and in figure 14 for the more complex fracture process of the $[\pm 45]_s$ angleply laminate. As can be seen, the microstructural characteristics are identical for the solid and notched specimens for each laminate. This phenomenon was also present in the CODSTRAN predictions which are listed in table IV. Results for the unidirectional and $[\pm 45]_s$ laminates, as well as all the other laminates, indicate that neither the presence of a defect nor the type of defect affect the primary mode of fracture in these G/E $[\pm \theta]_s$ laminates. Therefore, use of the fracture surface of the notch/slit laminate to represent the microstructural characteristics of a particular laminate is valid.

Figure 13. - The microstructural fracture surface characteristics of the unidirectional G/E laminate.

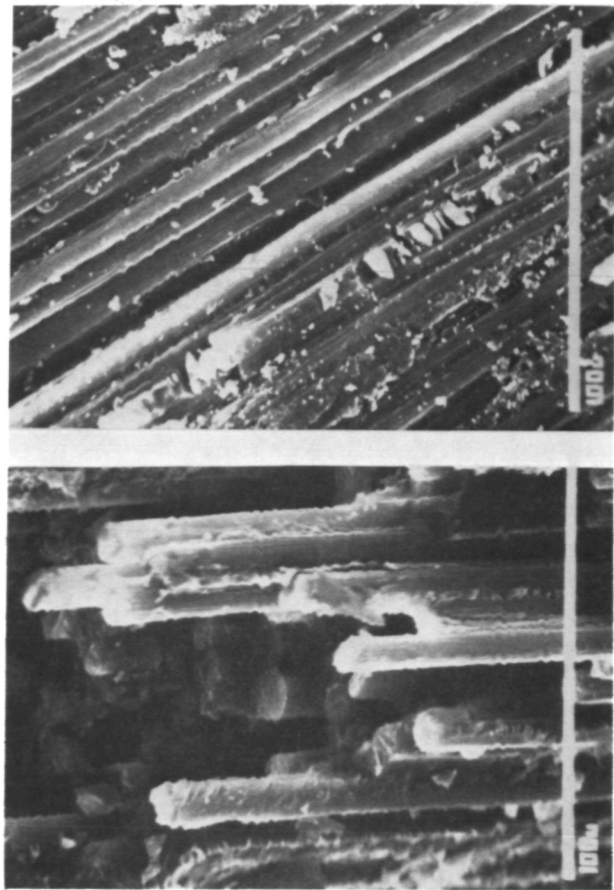
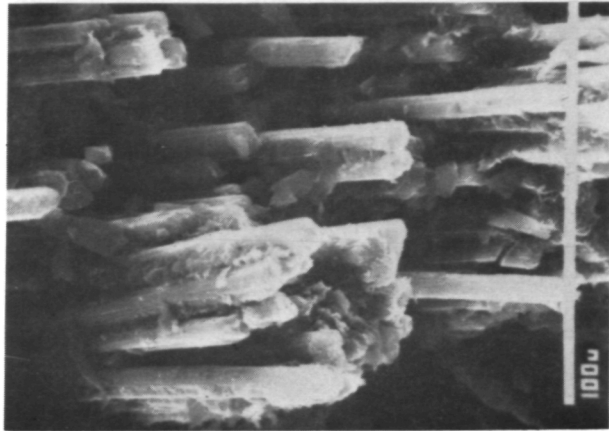
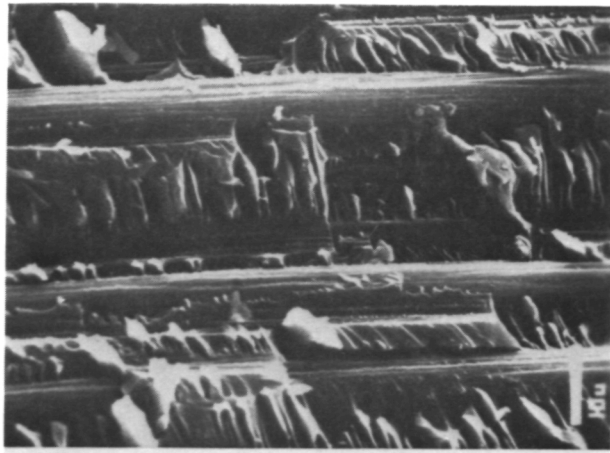
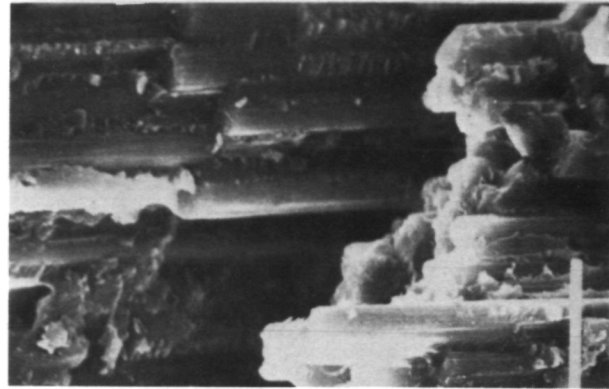
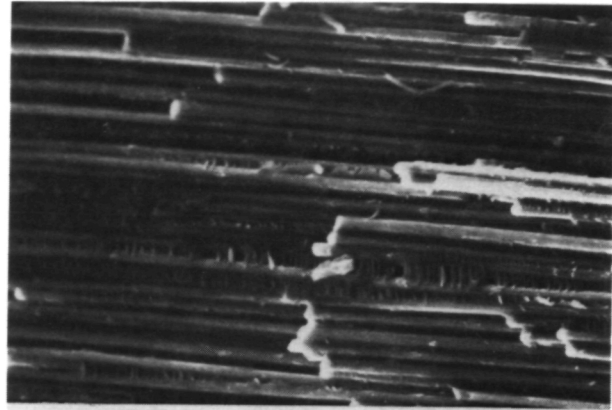
Figure 14. - Fracture surface characteristics of the $[\pm 45]_s$ G/E laminate.
